PERFORMANCE CHARACTERISTICS OF THE DEEP SPACE 1 FLIGHT SPARE ION THRUSTER LONG DURATION TEST AFTER 21,300 HOURS OF OPERATION

Anita Sengupta, John R. Anderson, and John R. Brophy
Jet Propulsion Laboratory
California Institute of Technology
4800 Oak Grove Drive
Pasadena, CA 91109
818-393-3430
Anita.Sengupta@jpl.nasa.gov

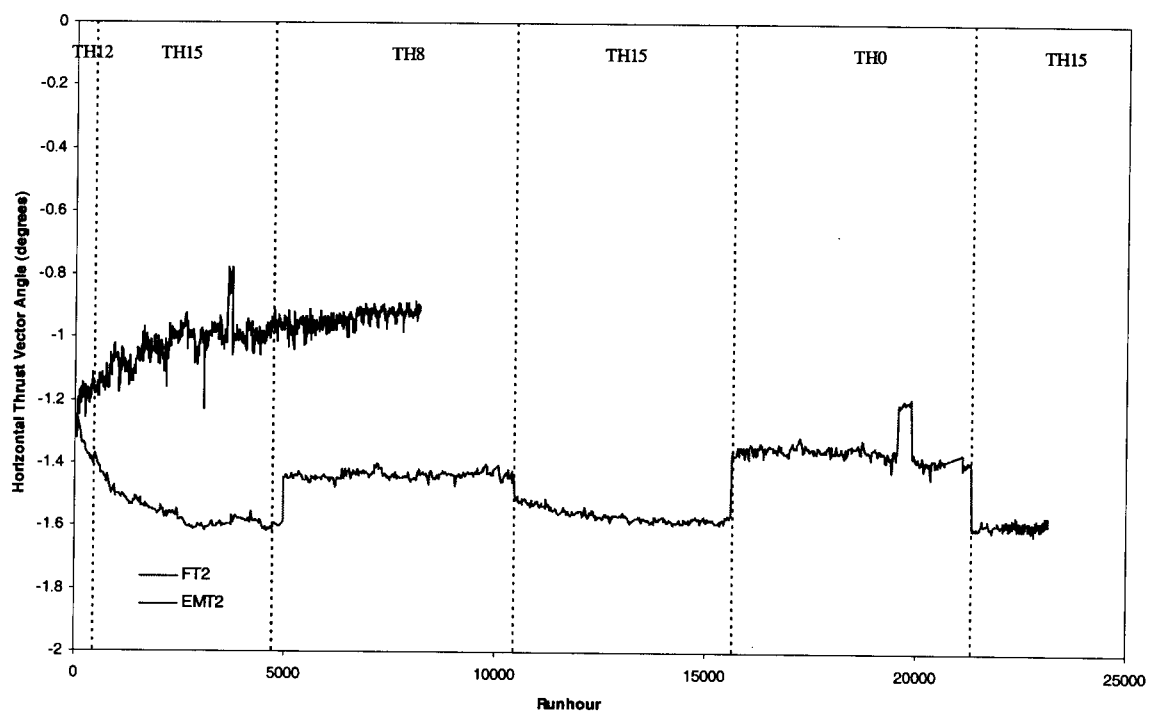
Shown in Fig. 24 is a comparison of the horizontal thrust vector angle, for FT2 and EMT2. Determination of the thrust vector is important for spacecraft trajectory analysis, as non-axial thrust must be accounted for, and corrected. For both thrusters, observed variations in the vertical and horizontal angle are about 0.2° and 0.4° , respectively. Small jumps of less than 0.2° occur when the power level is changed, with a trend to increasing the thrust vector angle as the thruster wears. Such shifts have been measured over the three test segments operated at the TH15 power point. A typical spacecraft gimbal system can easily compensate for the changes in thrust vector exhibited by FT2, over the past 23,000 hours. Overall, the average thrust vector has been relatively constant during operation over each test segment, with the exception of the first TH15 test segment. Variation of thrust vector as a function of power level, indicates a larger horizontal angle with an increase in power.¹⁸

Fig. 24 Horizontal Thrust Vector Angle Comparison for FT2and EMT2

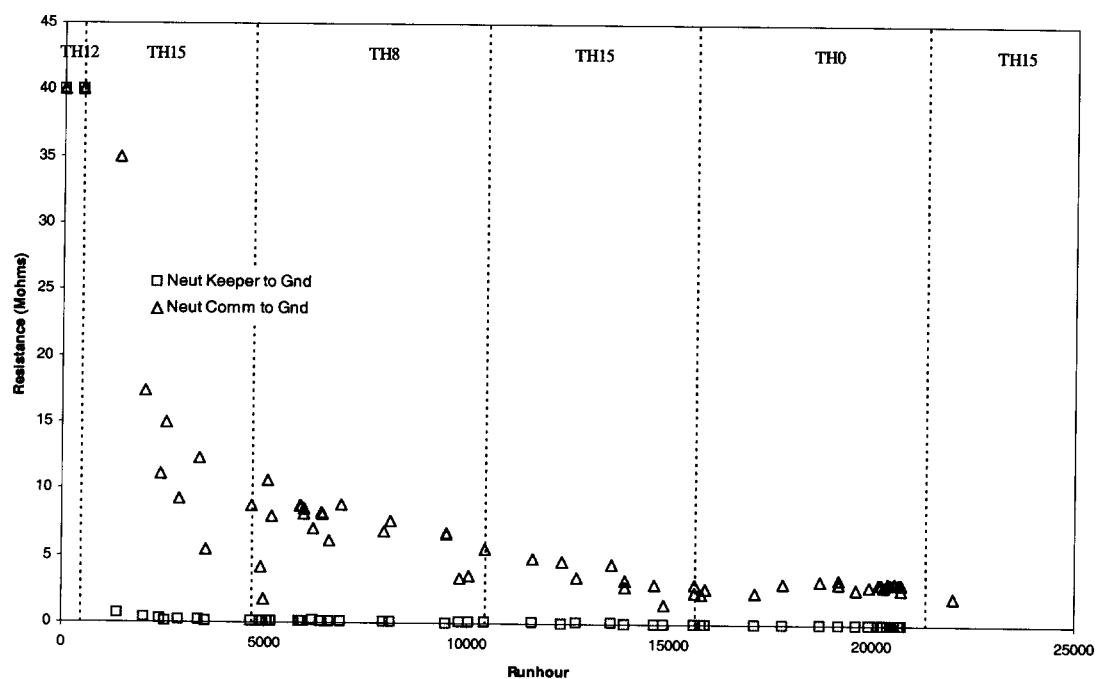
Fig. 25 FT2 Neutralizer Keeper and Neutralizer Common To Ground Resistance

Fig. 25 is a plot of neutralizer keeper and neutralizer common impedances to facility ground. The impedance of both components rapidly fell during the first 2000 hours of operation. The impedance for neutralizer keeper to ground dropped to from 10 GΩ to approximately 30-40 kW and has remained there to the present day. The cause of the degradation in the neutralizer keeper-facility ground impedance will not be determined until the neutralizer can be inspected after completion of the FT2 test. The impedance loss for neutralizer common to ground, however, decreased at a lower initial rate, but continued to decrease from 5000 to 15,000 hours, dropping from an initial value of 1 GW to 3 MW. During the TH0 test segment, from 15,617 to 21,306 hours, the neutralizer common to ground impedance remained constant. Possible causes for the reduction in neutralizer common and keeper to facility ground impedance include deterioration of wiring insulation and degradation of the neutralizer propellant flow isolator as well as carbon deposits back sputtered from the graphite panels, providing a conductive path to ground. It is possible to operate the thruster if either the neutralizer keeper or neutralizer common is shorted to facility ground however; the thruster would no longer be decoupled from ground.

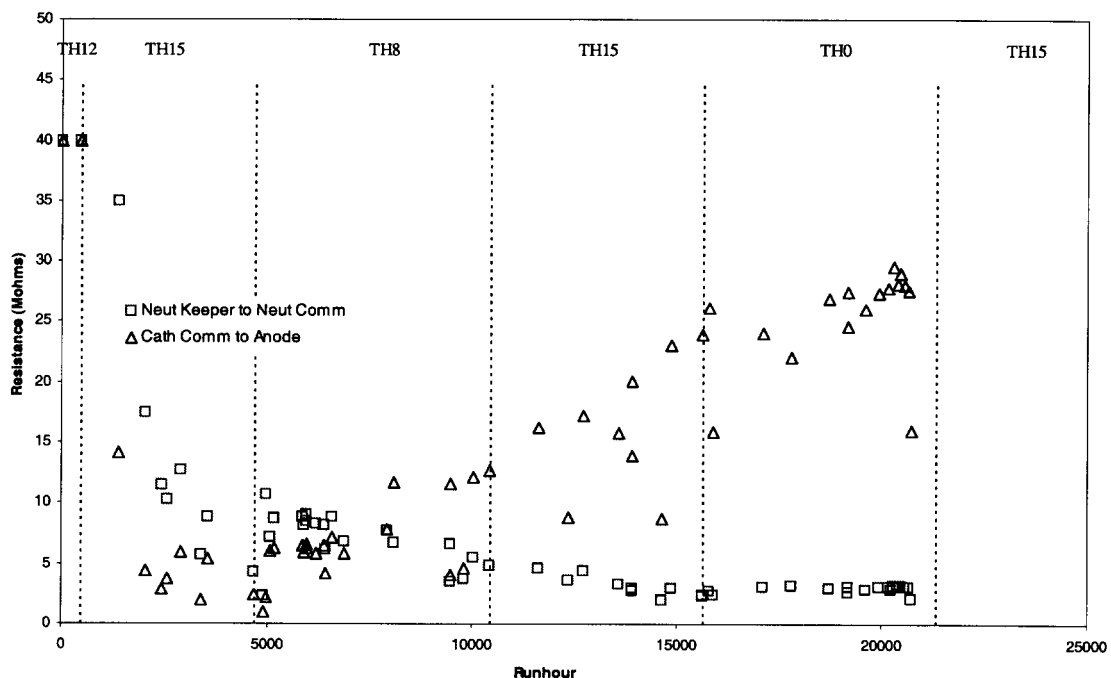
Fig. 26 shows degradation of neutralizer keeper to neutralizer common impedance. The neutralizer keeper to common impedance fell most significantly during the first 2000 hours, and leveled off at approximately 3 MΩ by 15617 hours. Degradation of neutralizer keeper-

Fig. 26 also shows degradation of discharge cathode common to anode impedance. At the start of testing the impedance was greater than 10 GW. From 2000 hours to 5000 hours, the resistance had decreased to approximately 4 MW. At approximately 5000 hours, the impedance began to increase, climbing up to 30 MW by 20,000 hours. Possible causes for the initial reduction in cathode common to anode impedance include a conducting layer depositing on the ceramic used to isolate cathode common from anode or a conductive path between pins in the thruster wiring cable connector. Degradation of cathode common-anode impedance can reduce discharge chamber performance, and if severe enough, can cause thruster failure.

Fig. 26 FT2 Neutralizer Keeper to Neutralizer Common and Cathode Common to Anode Resistance

neutralizer common impedance, if severe enough, can cause thruster failure. If leakage current is sufficiently high, the neutralizer discharge cannot be maintained. At impedances above 100 Ω, neutralizer performance and margin from plume mode would be reduced, but the neutralizer would still provide sufficient electron current for beam neutralization. Possible causes for the reduction in neutralizer keeper-neutralizer common impedance include neutralizer heater radiation shielding contacting the neutralizer keeper and a conducting layer depositing on the ceramic used to isolate neutralizer keeper from neutralizer common.

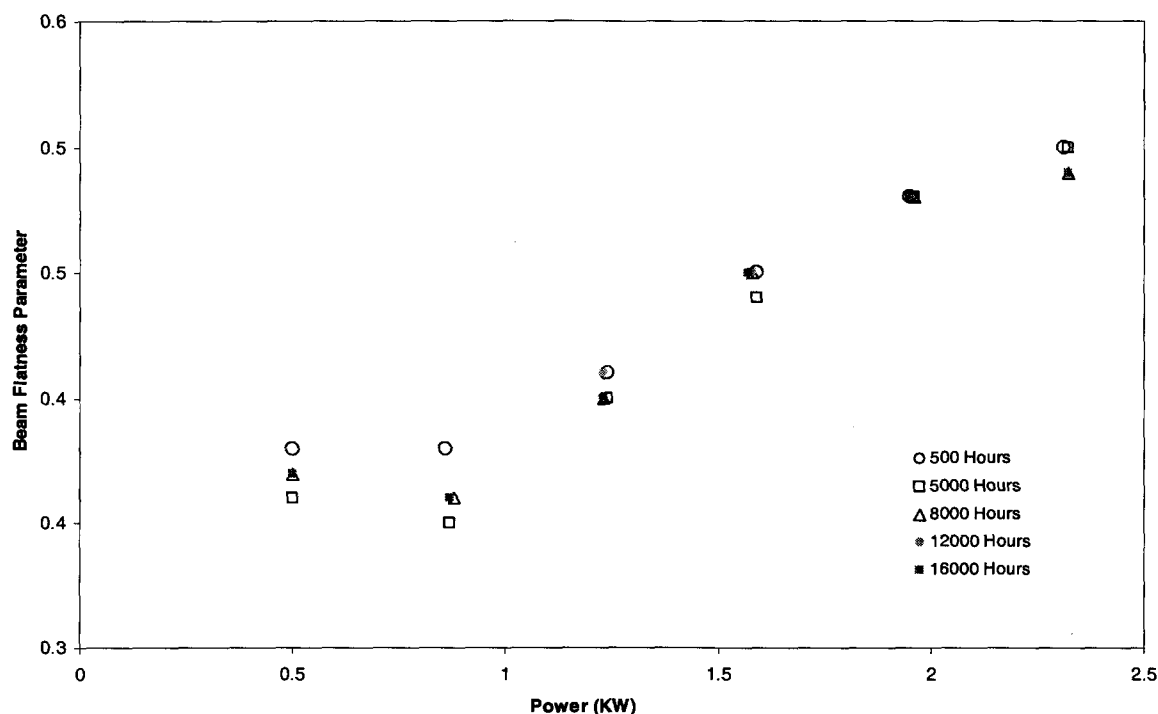
Fig. 27 FT2 Beam Flatness versus Power
